Examples of potential improvements to make the current infrastructure safer and more cycling-friendly.

Appendix to Killarney Cycling Club's submission on Proposed Cycle Paths in Killarney (Part 8 – Killarney Cycle Lanes). Submitted to Killarney Municipal District, Kerry County Council.

This appendix provides examples from the existing cycling infrastructure, from a cyclist's viewpoint, to help highlight problematic issues that might be addressed in relation to that overall development of the cycling infrastructure.

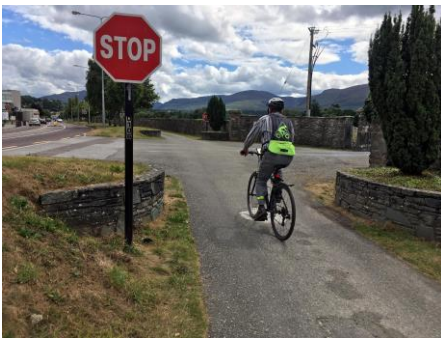
Example 1: Muckcross Road

There is an excellent segregated and busy cycling path on the Muckcross Road but there are two STOP signs giving priority to two private entrances – a farm and a hotel.

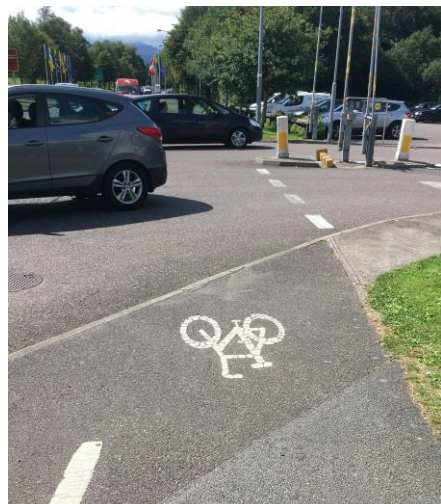
Example 2: Dr. Hans Liebherr Road

The cycle path on Dr. Hans Liebherr Road appears to be discontinued at the entrance to Lidl.

There is no indication for traffic entering/exiting that it may be crossing a cycle lane (if it is a cycle lane at that point?)

This also creates ambiguity about whether cyclists or drivers have 'right of way' here.

Either way, it is a potentially hazardous spot for cyclists.

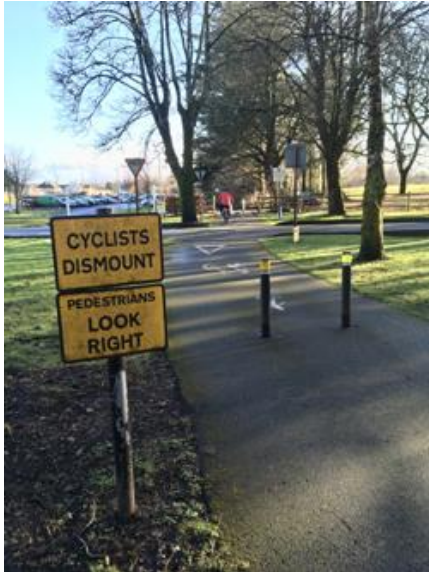
Example 3: Fossa Way / Golf Club entrance

On the Fossa Way path cyclists are instructed to 'dismount' for the entrance to Killarney Golf and Fishing Club.

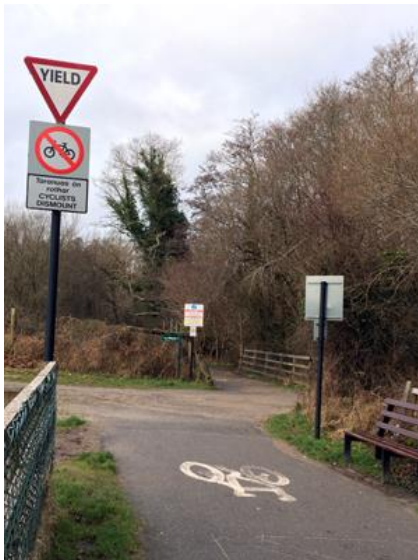
Example 4: Fossa Way / track junction

On the Fossa Way path cyclists are instructed to 'dismount' at an intersection with a little-used, un-paved track.

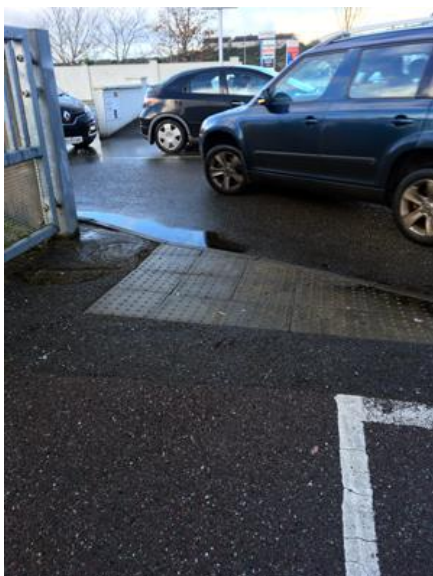
Example 5: Deerpark Rd

On Deerpark Rd. the cycle path to the Deerpark Shopping Centre is discontinued for the entrance to Aldi.

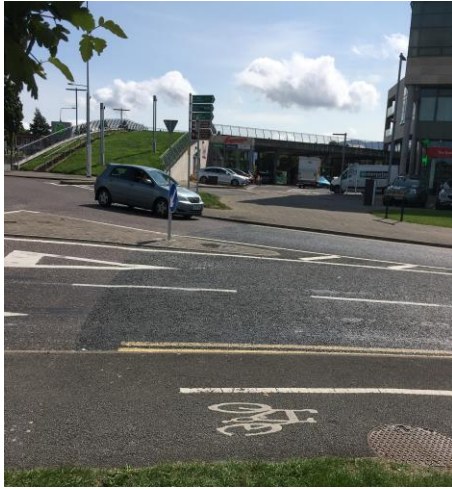
Example 1 Dr. Hans Liebherr Road

At the eastern end of Hans Liebherr Road (Cleeny Roundabout) the cycle lane ends/begins suddenly on top of a footpath with no cycling entry/exit.

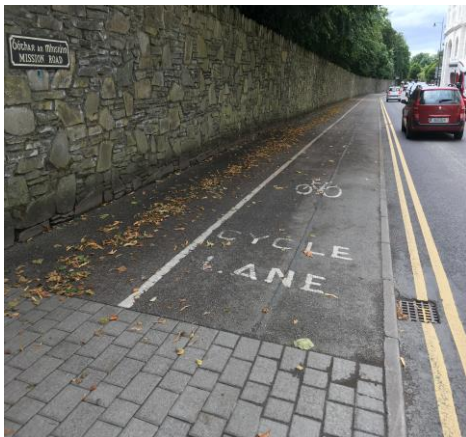
Example 2: Mission Road

The cycle lane on Mission Road begins suddenly on a footpath with a high kerb – there is no cycling access to it.

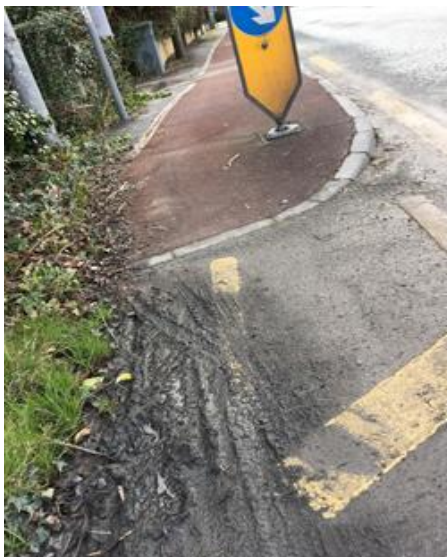
Example 1: N72 East

The entrance to N72 cycle path heading east at Fossa is narrow and at a typical pinch-point with 'traffic-calming' measures. This is compounded by the gradual collection of debris.

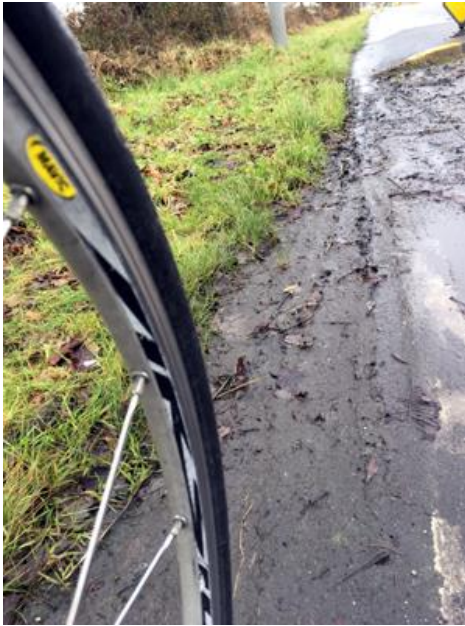
Example 2: N72 West

The entrance to the N72 cycle lane going west at Lisivageen is derelict and forces cyclists onto the road where a traffic-calming measure creates a pinch-point.

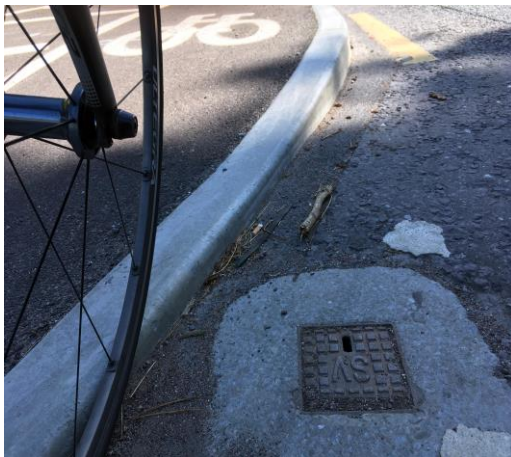
Example 3: N72 East

Access to the cycle lane here has a raised kerb going diagonally across the path.

It is very de-stabilizing when a cycle wheel strikes a raised diagonal surface.

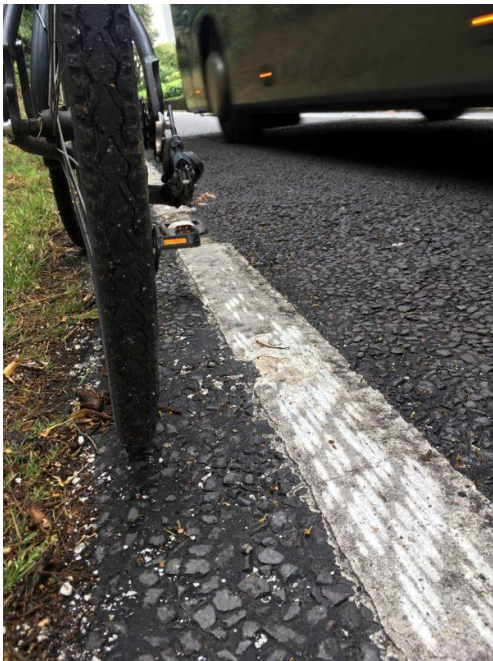
Example 1. Width and maintenance

This image was featured in the cycling press in 2017 as probably the narrowest cycle lane in Ireland (stickybottle.com, July 29th, 2017).

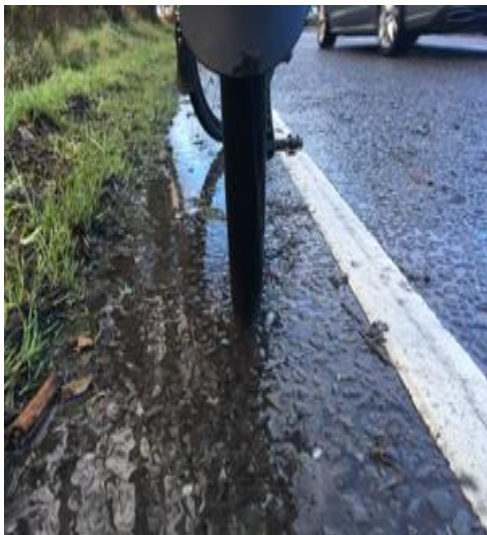
Even though some maintenance was done in the interim, it is still less than half a meter wide in parts.

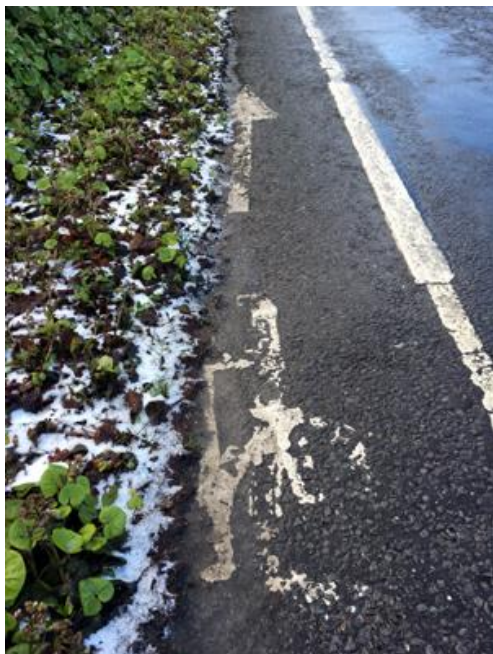
It's width is greatly reduced in parts due to lack of maintenance.

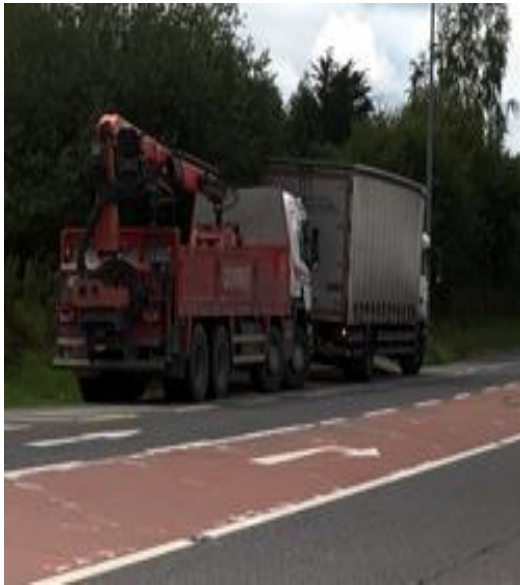
Example 2. Illegal parking, lack of protection and enforcement

The section opposite the Inver filling station is very hazardous due to persistent illegal parking on the cycle lane by customers, combined with a generally confused section of road (three lanes of traffic and frequent illegal parking on both sides of the road, with the sight-lines from exiting the filling station being obstructed)

The illegal parking forces cyclists out onto the road at this busy and confused section of road, and inexpensive measures would protect the cycle path (or see below for an example of a more comprehensive solution).

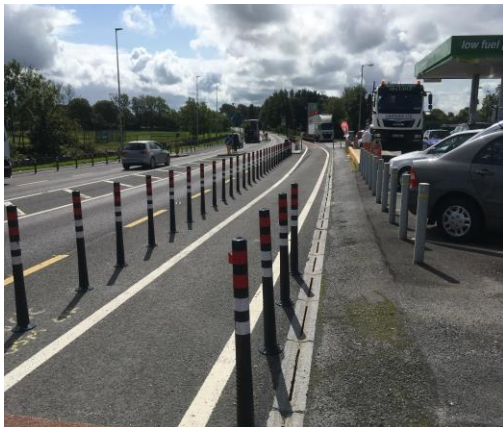
Example of a cycle path protected passing a filling station from Galway Co. Council

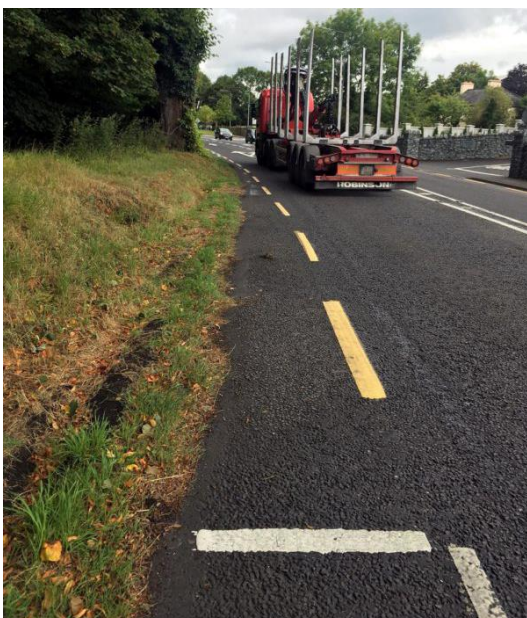
Example 3: Cycle lanes discontinued at more hazardous points

The cycle lane is just discontinued at some points, where it is needed most.

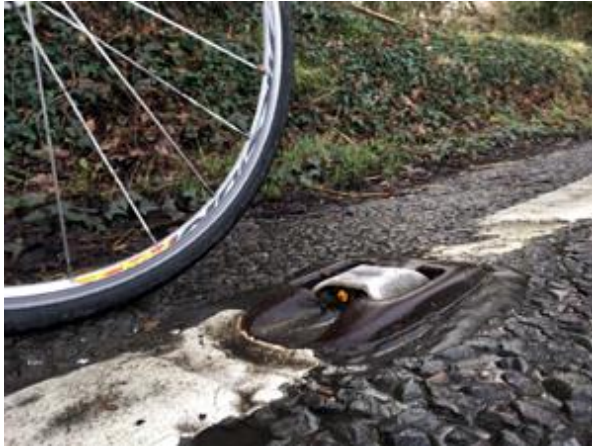
Example 4: Hazardous 'cats-eyes'

Most of the cycle lane is lined with raised 'cats-eyes' on the outside and cyclists should allow space to avoid these hazards.

However, in many places there is not adequate space to safely avoid the grass verge on the one side, and the cats-eyes on the other.

Therefore, many cyclists opt to ride out in the main carriageway so as to have safe space from these.
